EXPERIMENTAL INSTALLATION OF LARGE DIAMETER (48 in.) HIGH DENSITY POLYETHELENE CULVERT PIPE (HDPE)

CONSTRUCTION REPORT

SEPTEMBER 2000

CONSTRUCTION REPORT
Report # PE-09-00

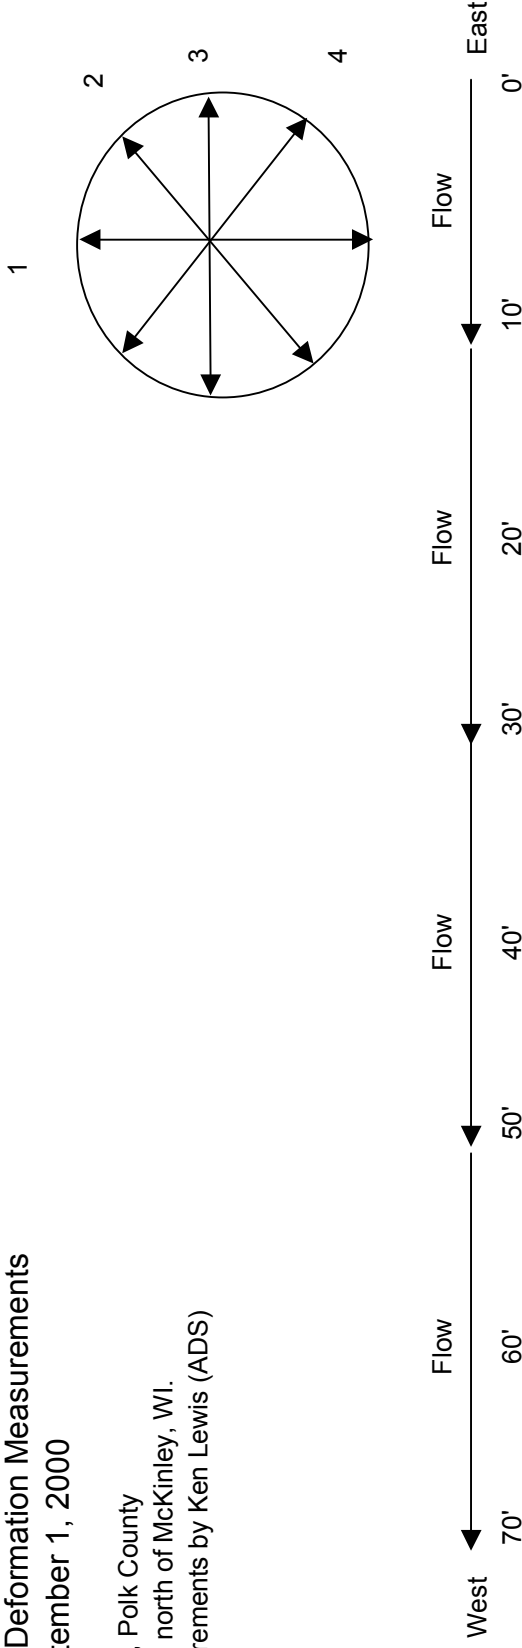
Pipe Deformation Measurements
September 1, 2000

CTH E, Polk County
2 Miles north of McKinley, WI.
Measurements by Ken Lewis (ADS)

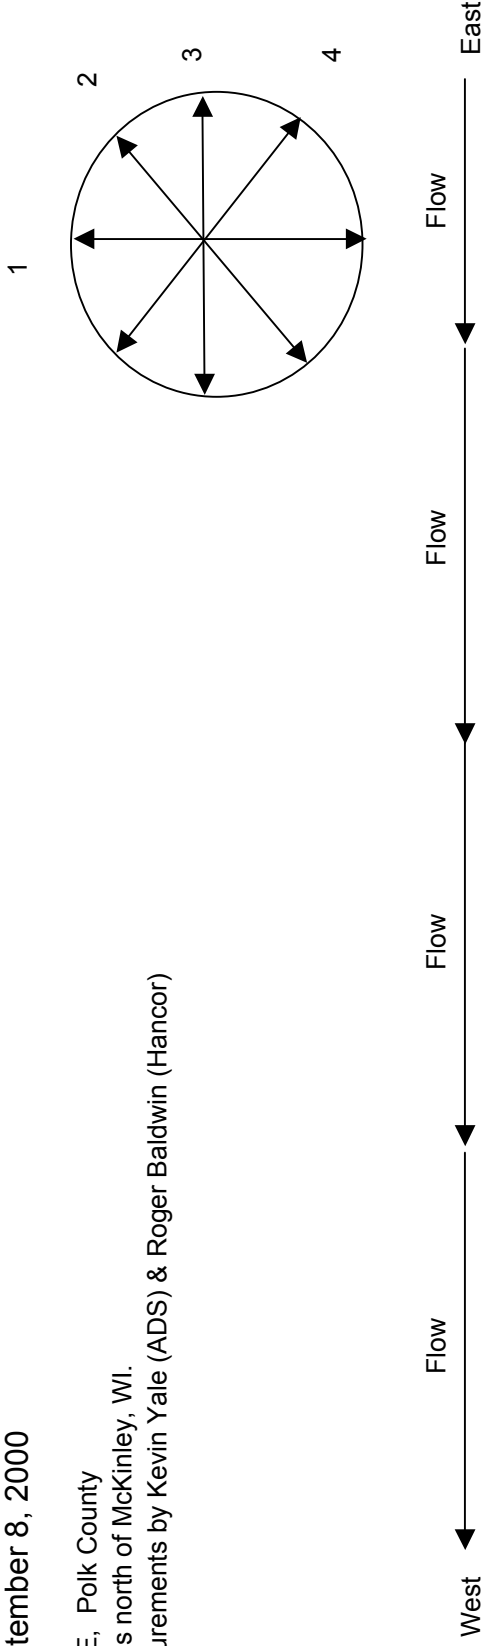
Pipe Deformation Measurements September 8, 2000

CTH E, Polk County
2 Miles north of McKinley, WI.
Measurements by Kevin Yale (ADS) & Roger Baldwin (Hancor)

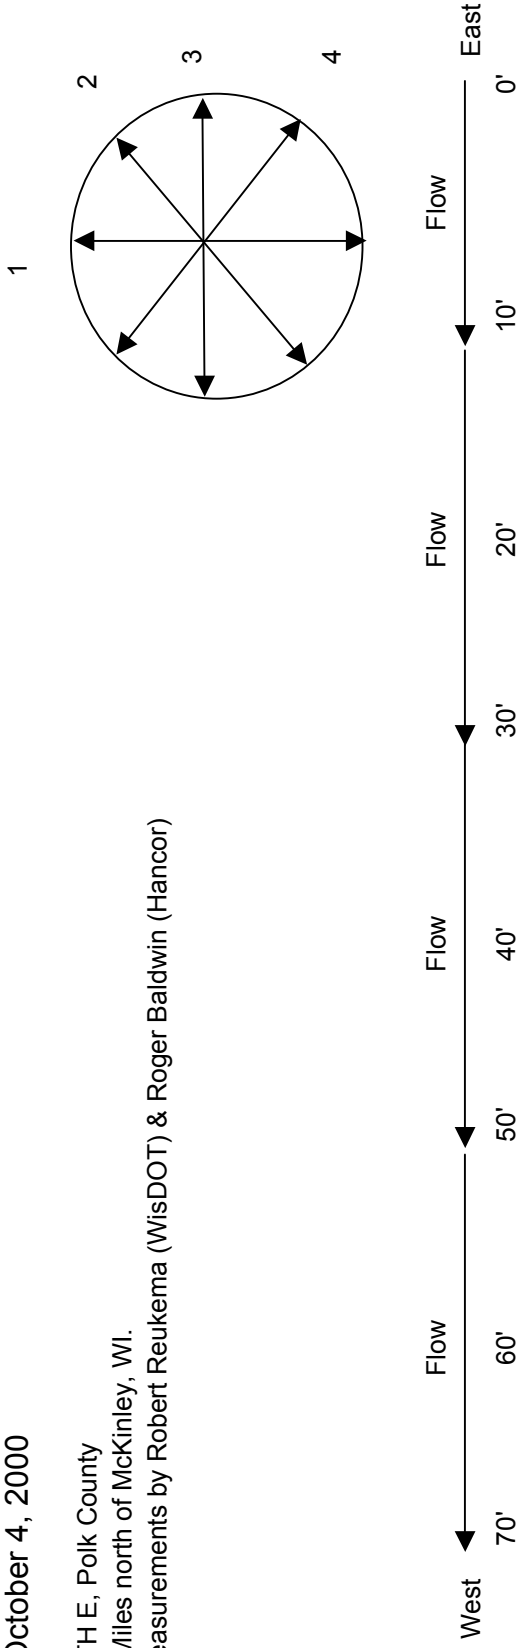
Pipe Deformation Measurements October 4, 2000

CTH E, Polk County
2 Miles north of McKinley, WI.
Measurements by Robert Reukema (WisDOT) & Roger Baldwin (Hancor)

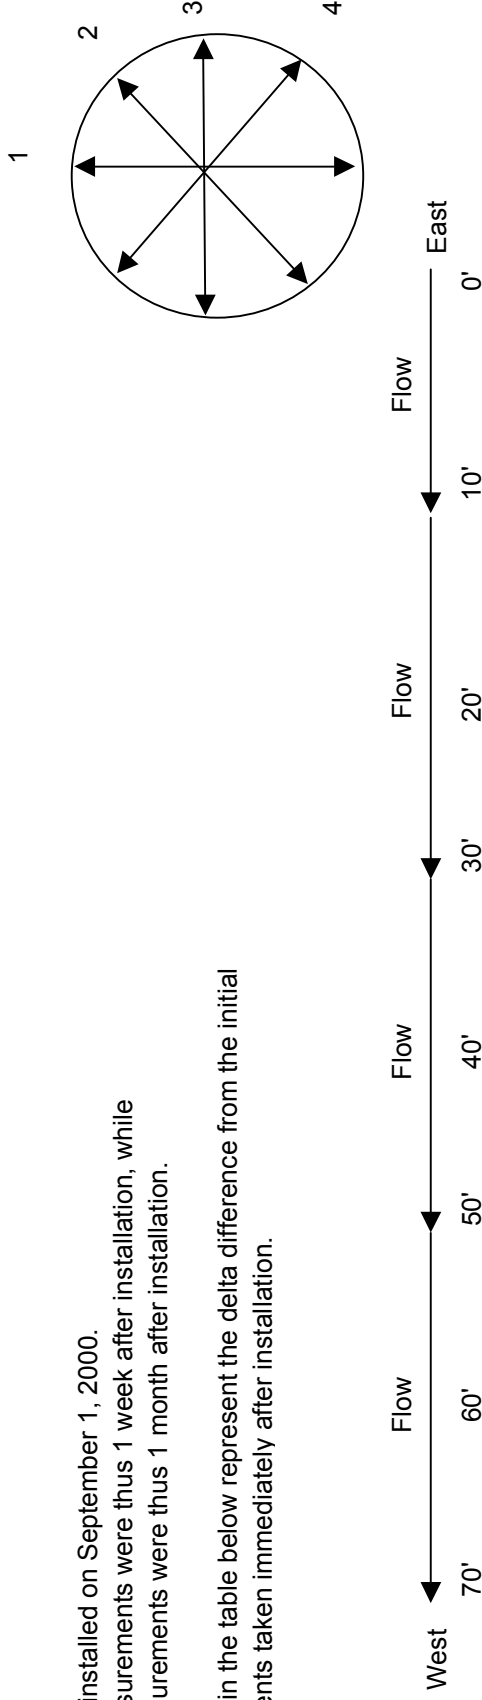
Pipes were installed on September 1, 2000.
 Sep. 8 measurements were thus 1 week after installation, while
 Oct. 4 measurements were thus 1 month after installation.

The Values in the table below represent the delta difference from the initial measurements taken immediately after installation.

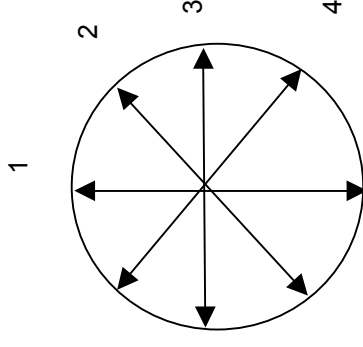
ADS Pipe Deformation Summary

Oct. 4 measurements were thus 1 month after installation.

The Values in the table below represent the delta difference from the initial measurements taken immediately after installation.

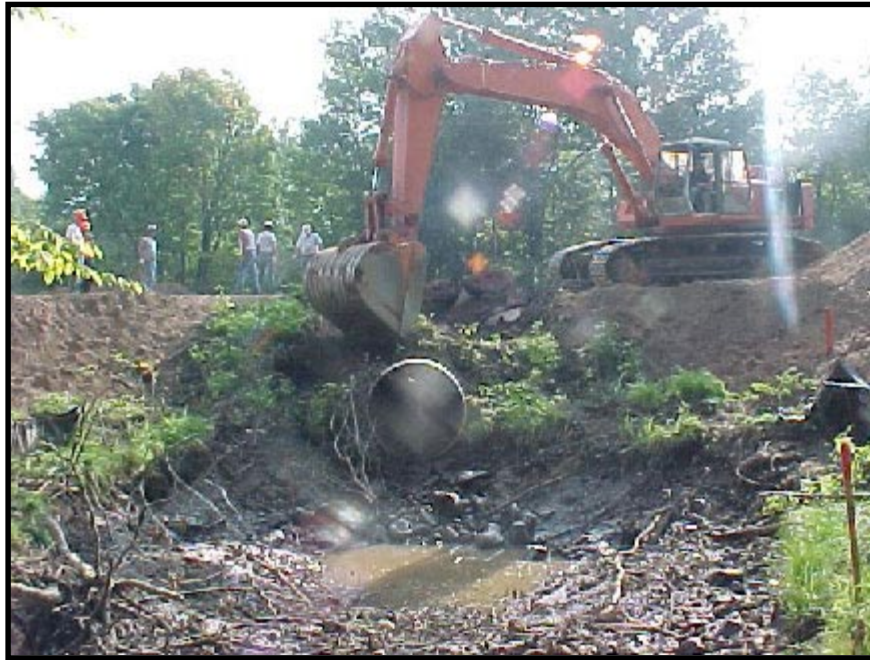
Upon removal of the existing 54 in. corrugated metal pipe (Prints 1-7, Appendix C), it was observed that the bottom of the pipe was deteriorated and corroded, probably due to standing acidic water in the bottom of the pipe. It was estimated that the pipe was approximately 25 years old.

Print 5. View of the old pipe being dug out looking from the outlet side.

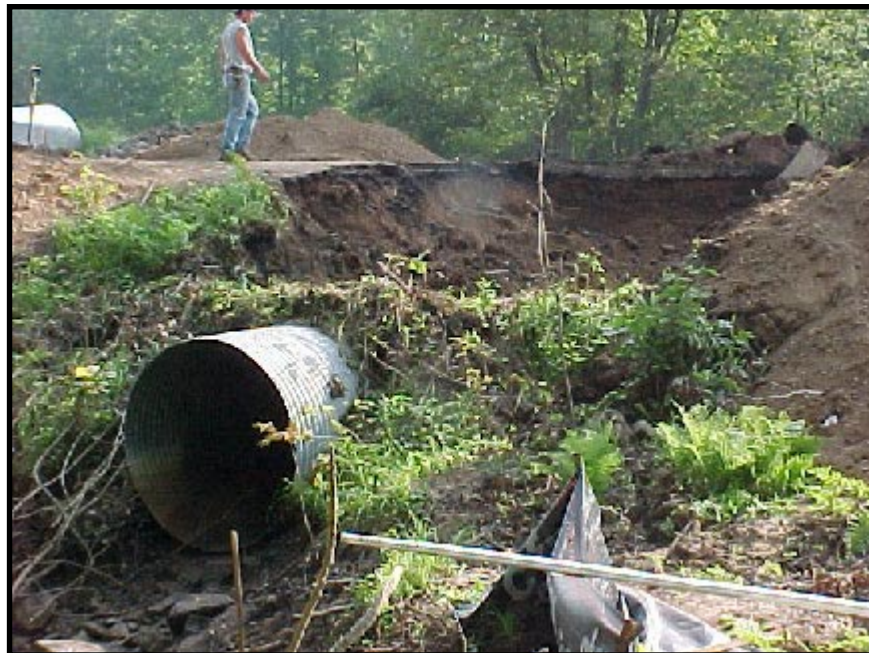
Print 6. View of the old pipe looking from the inlet side.
